St Andrew, Dalton le Dale
An Archaeological Watching Brief

February/March 2011

St Andrew's Church, Dalton le Dale.

An Archaeological Watching Brief, February/March 2011

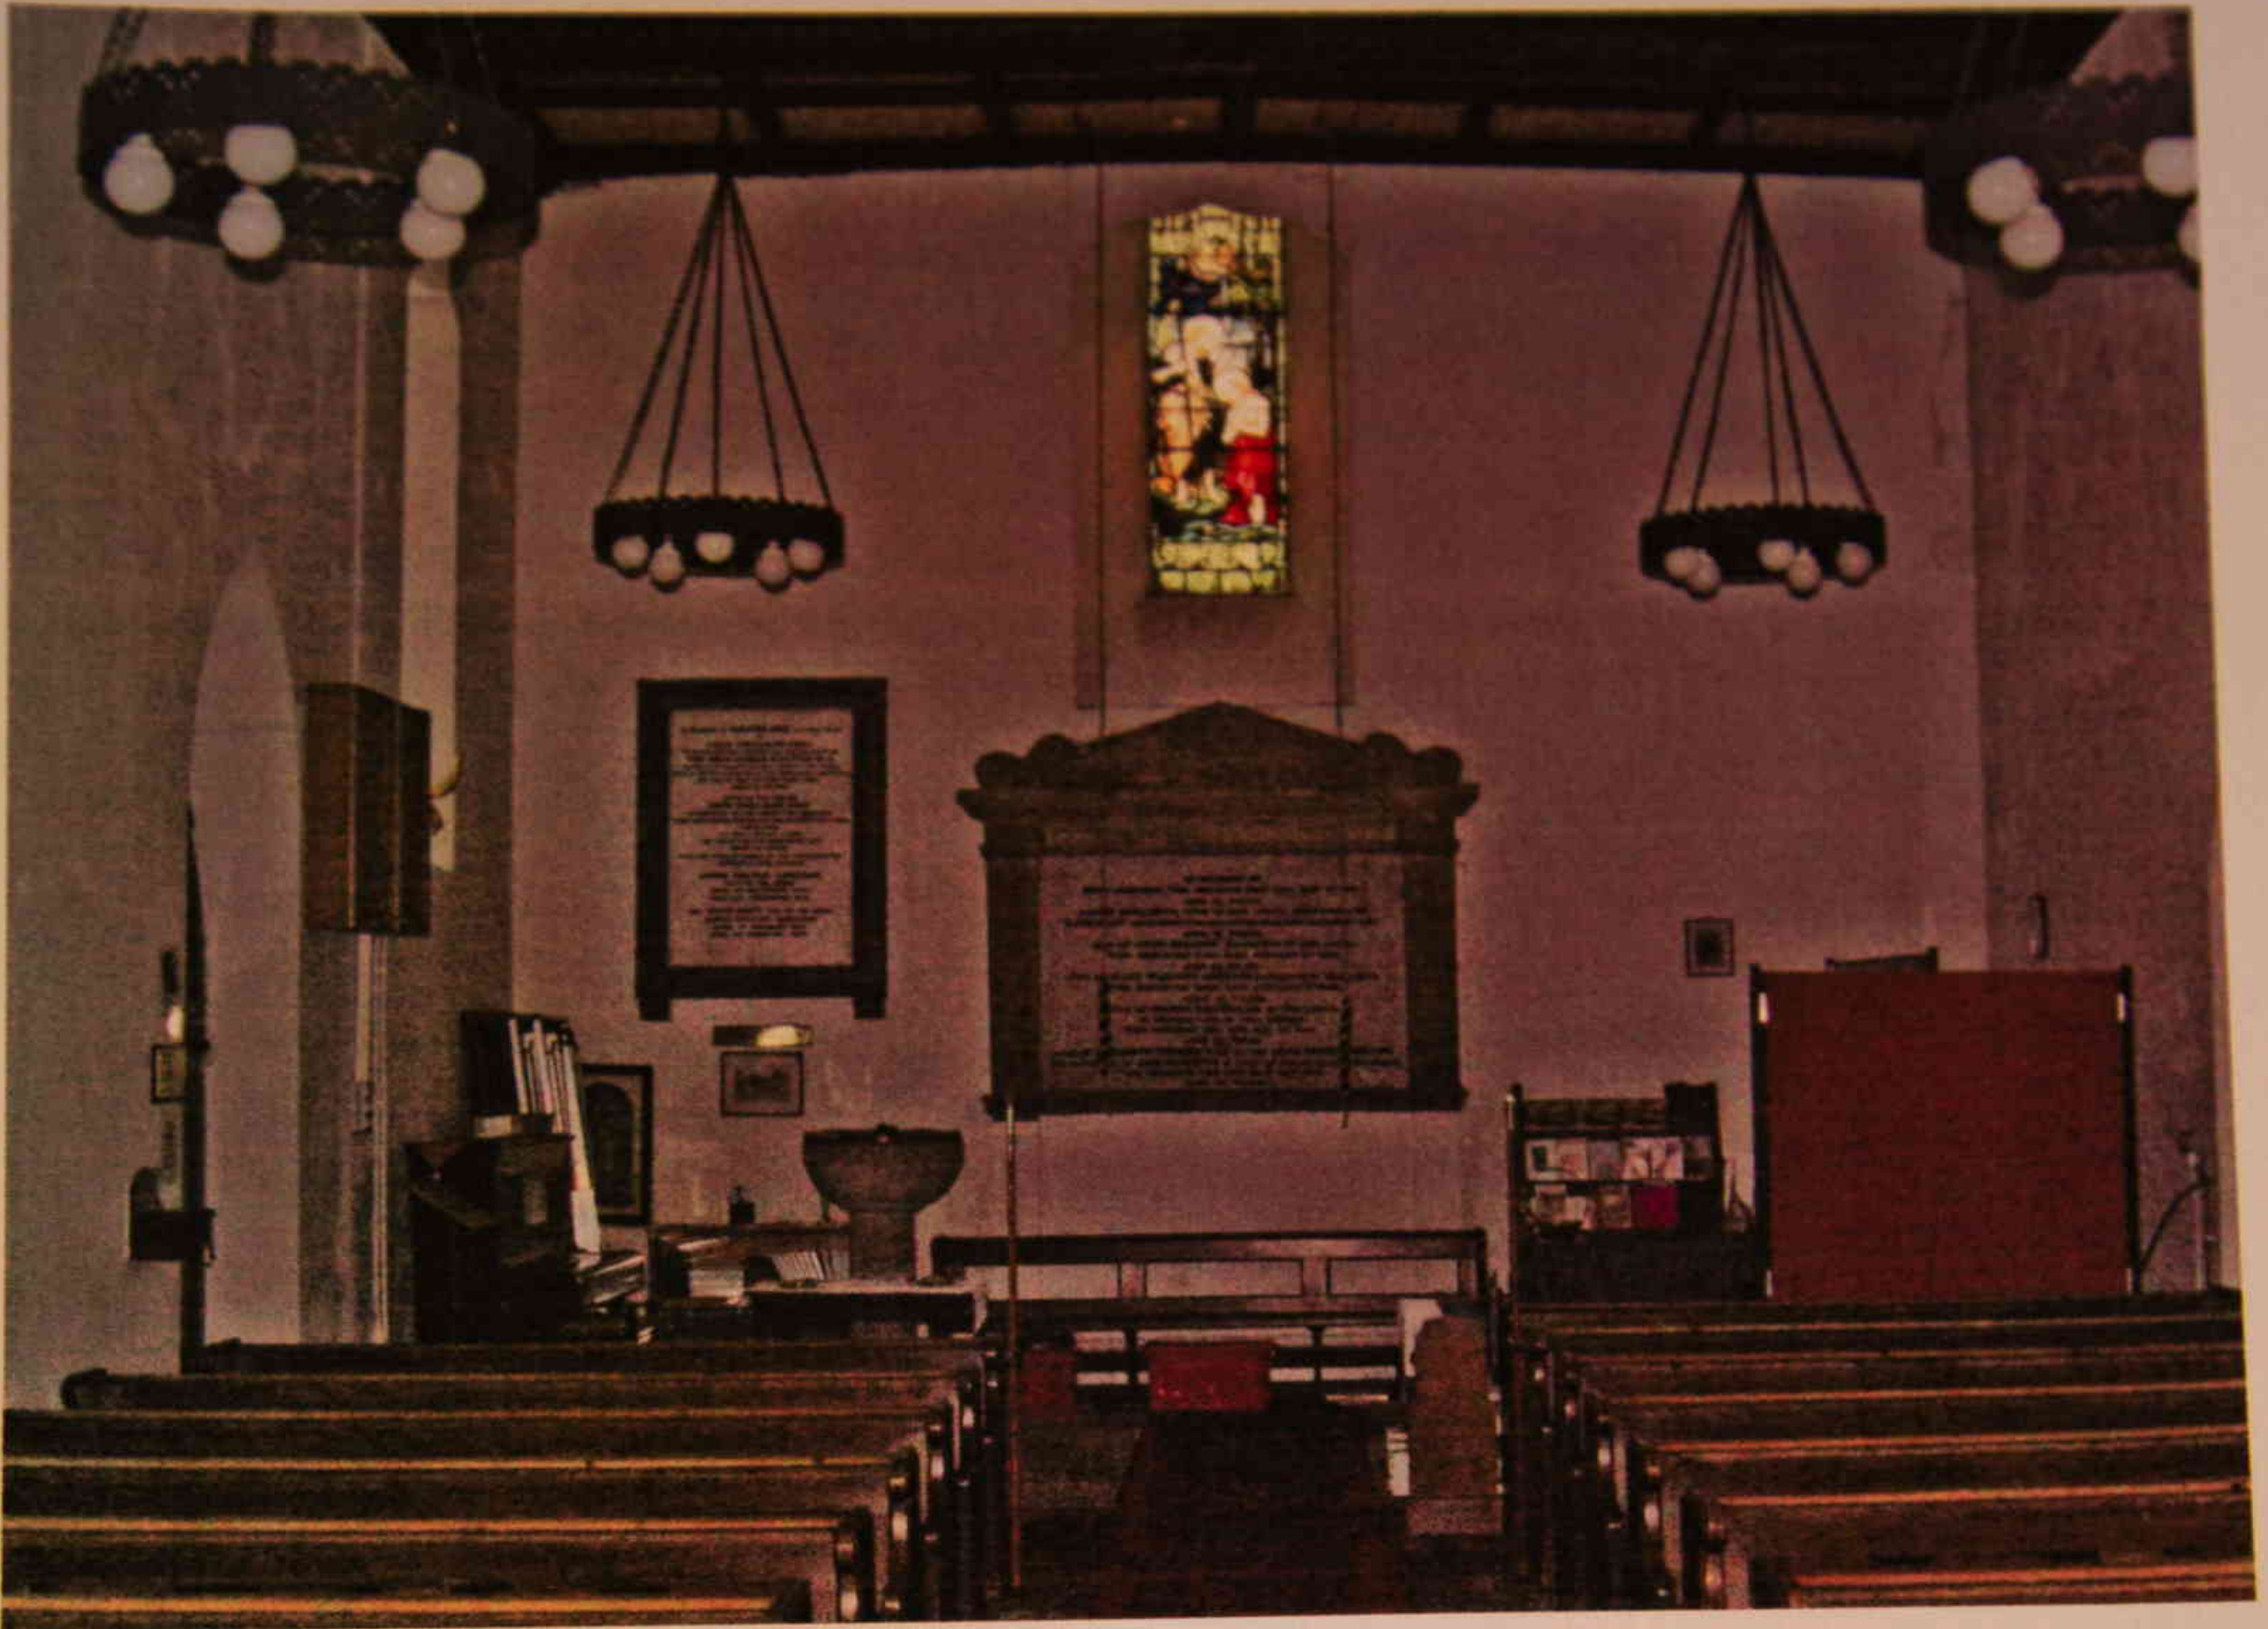
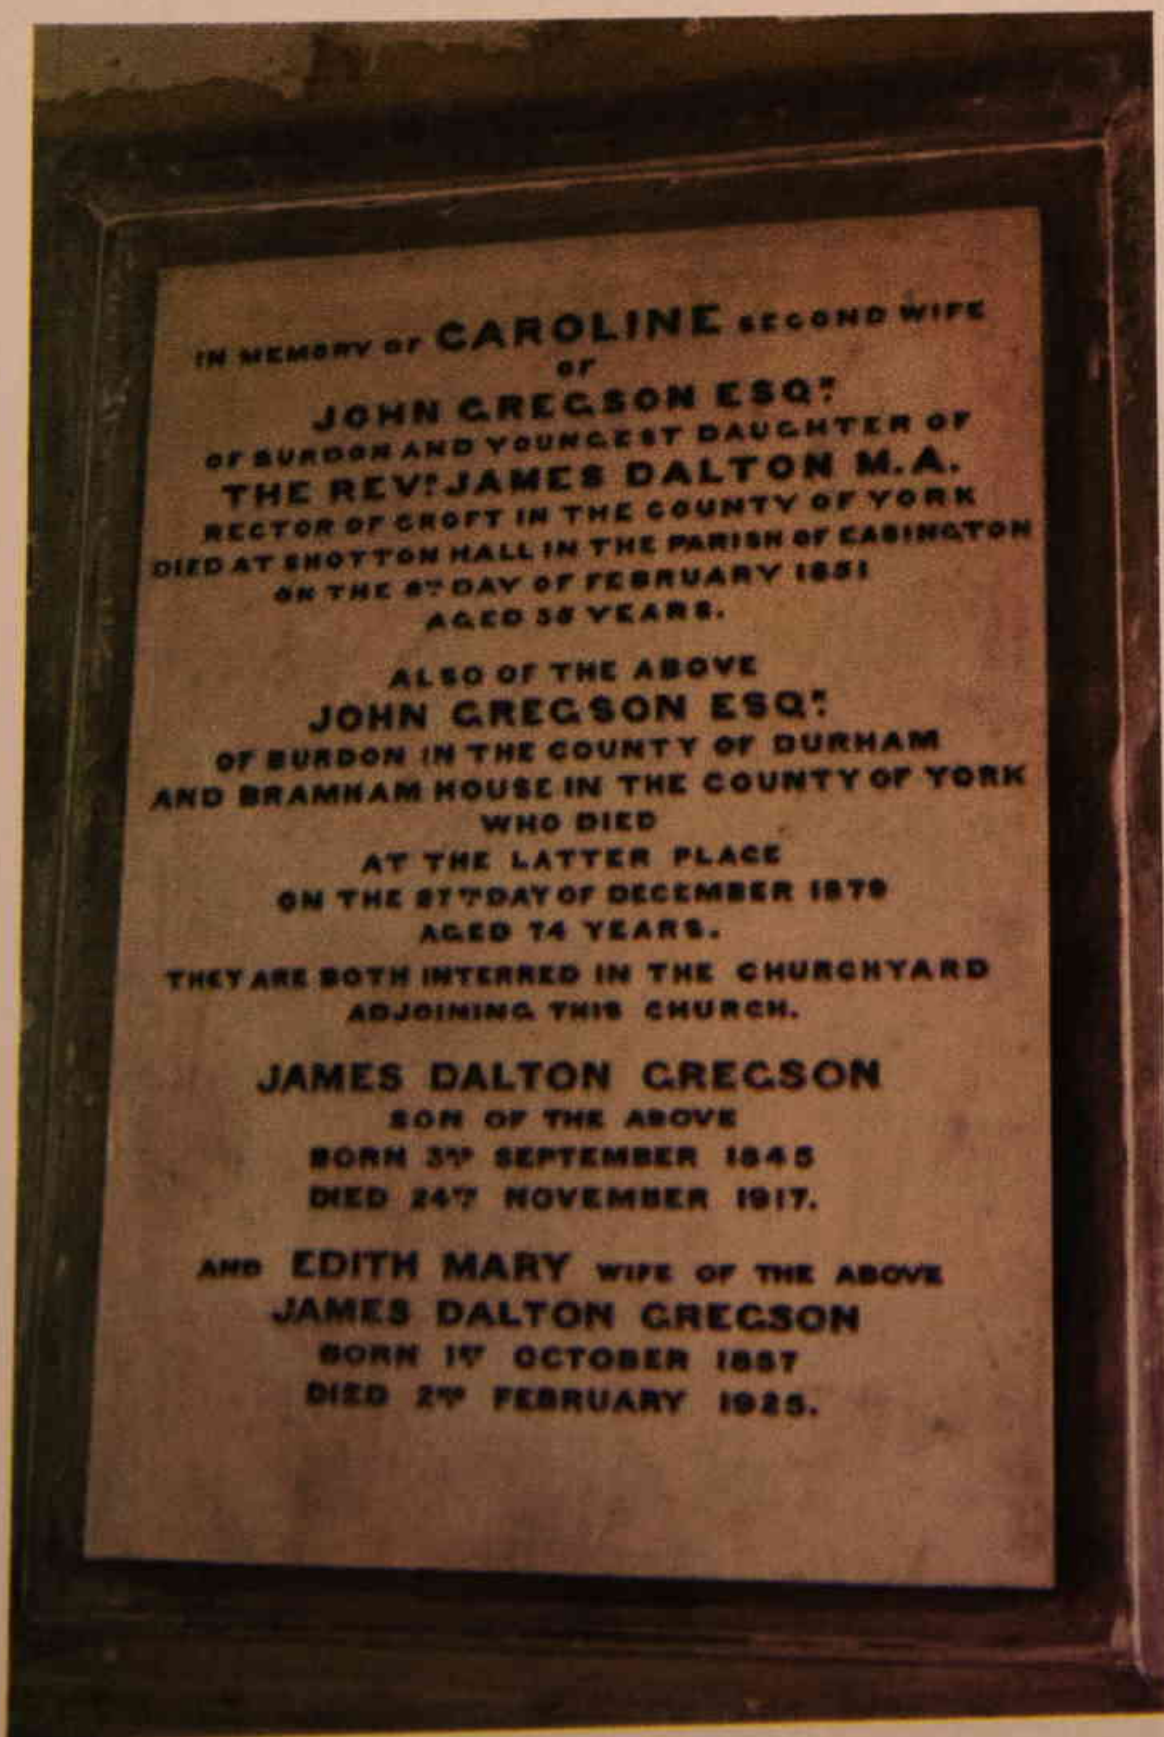
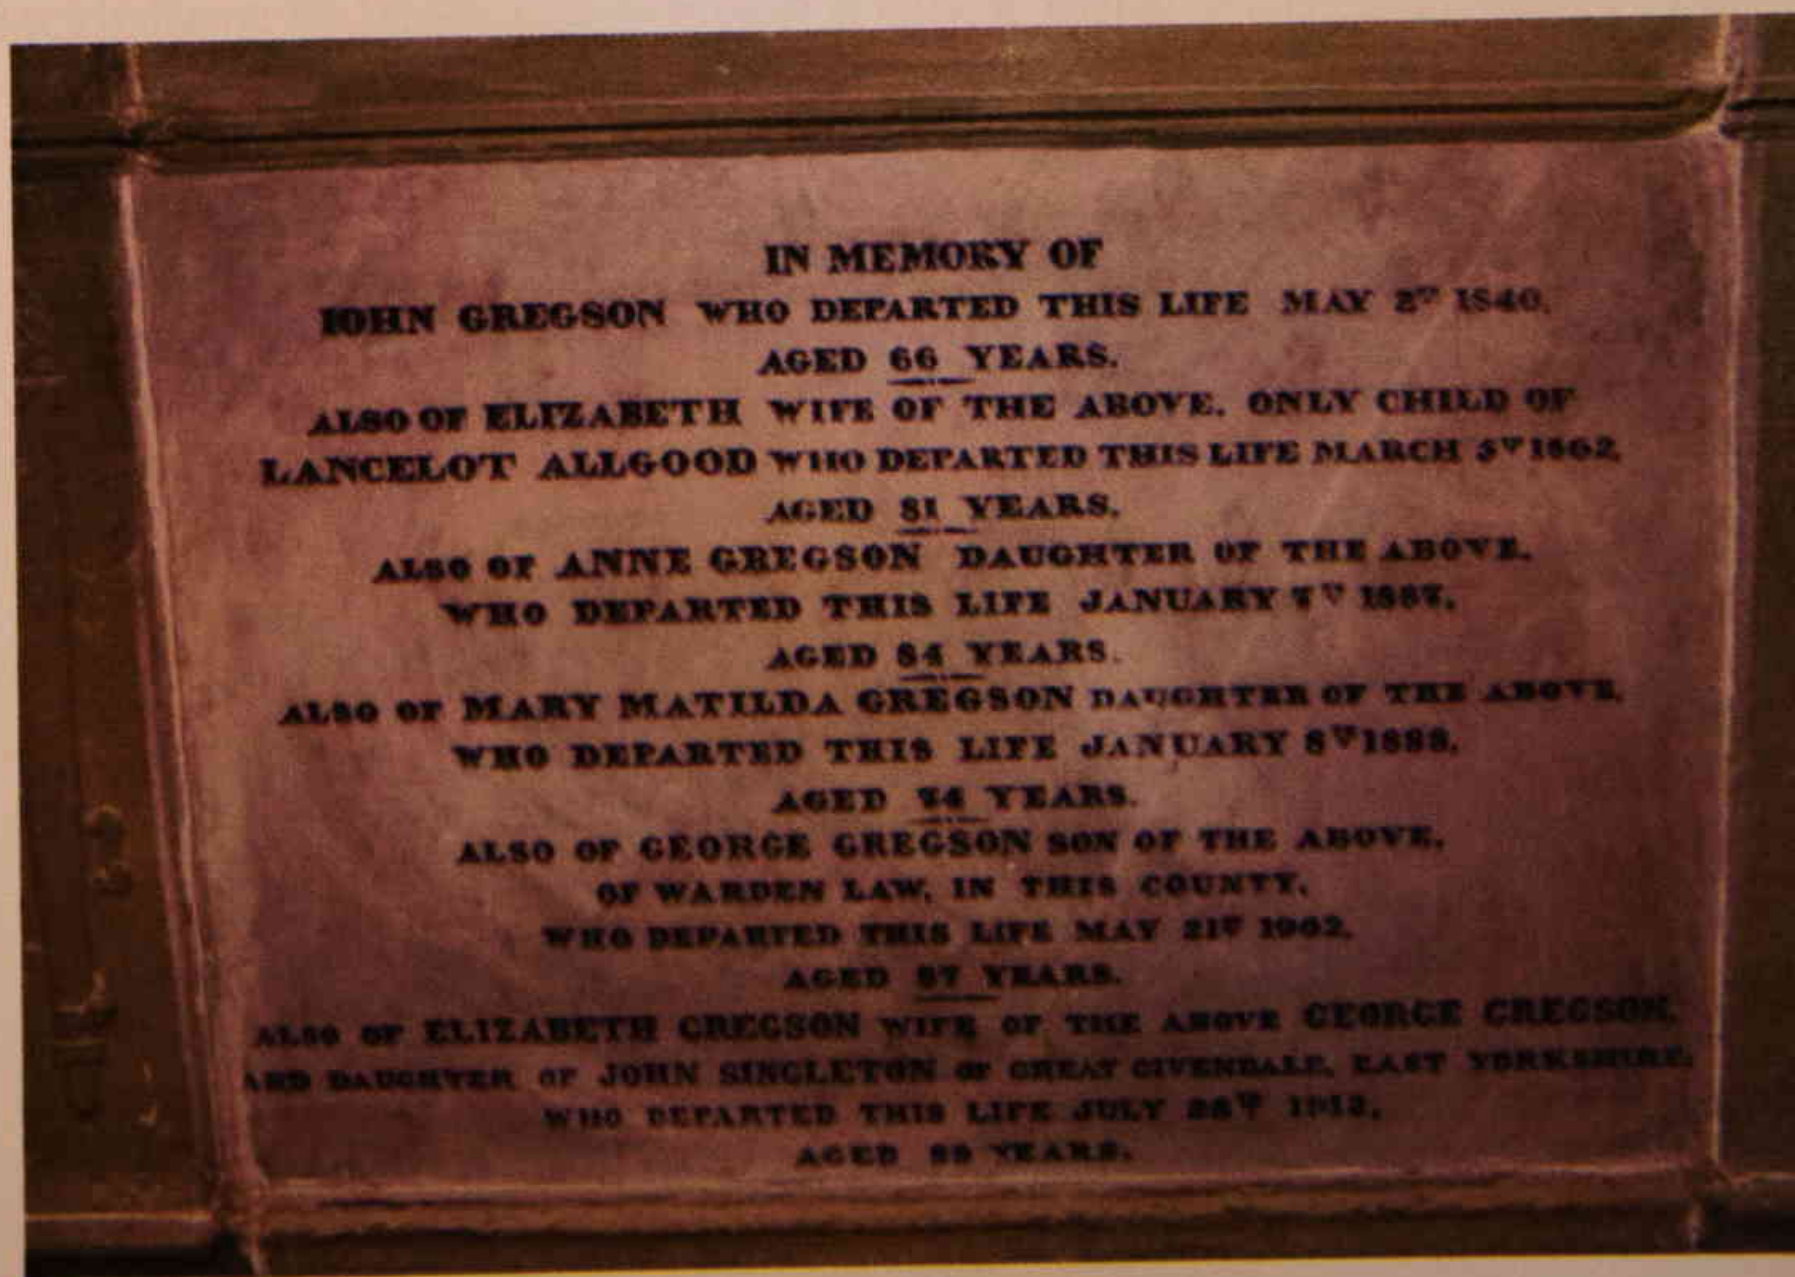
*The west end of the nave, before the present works,
and the two mural monuments which have been
re-sited (monument photos: C Downs)*

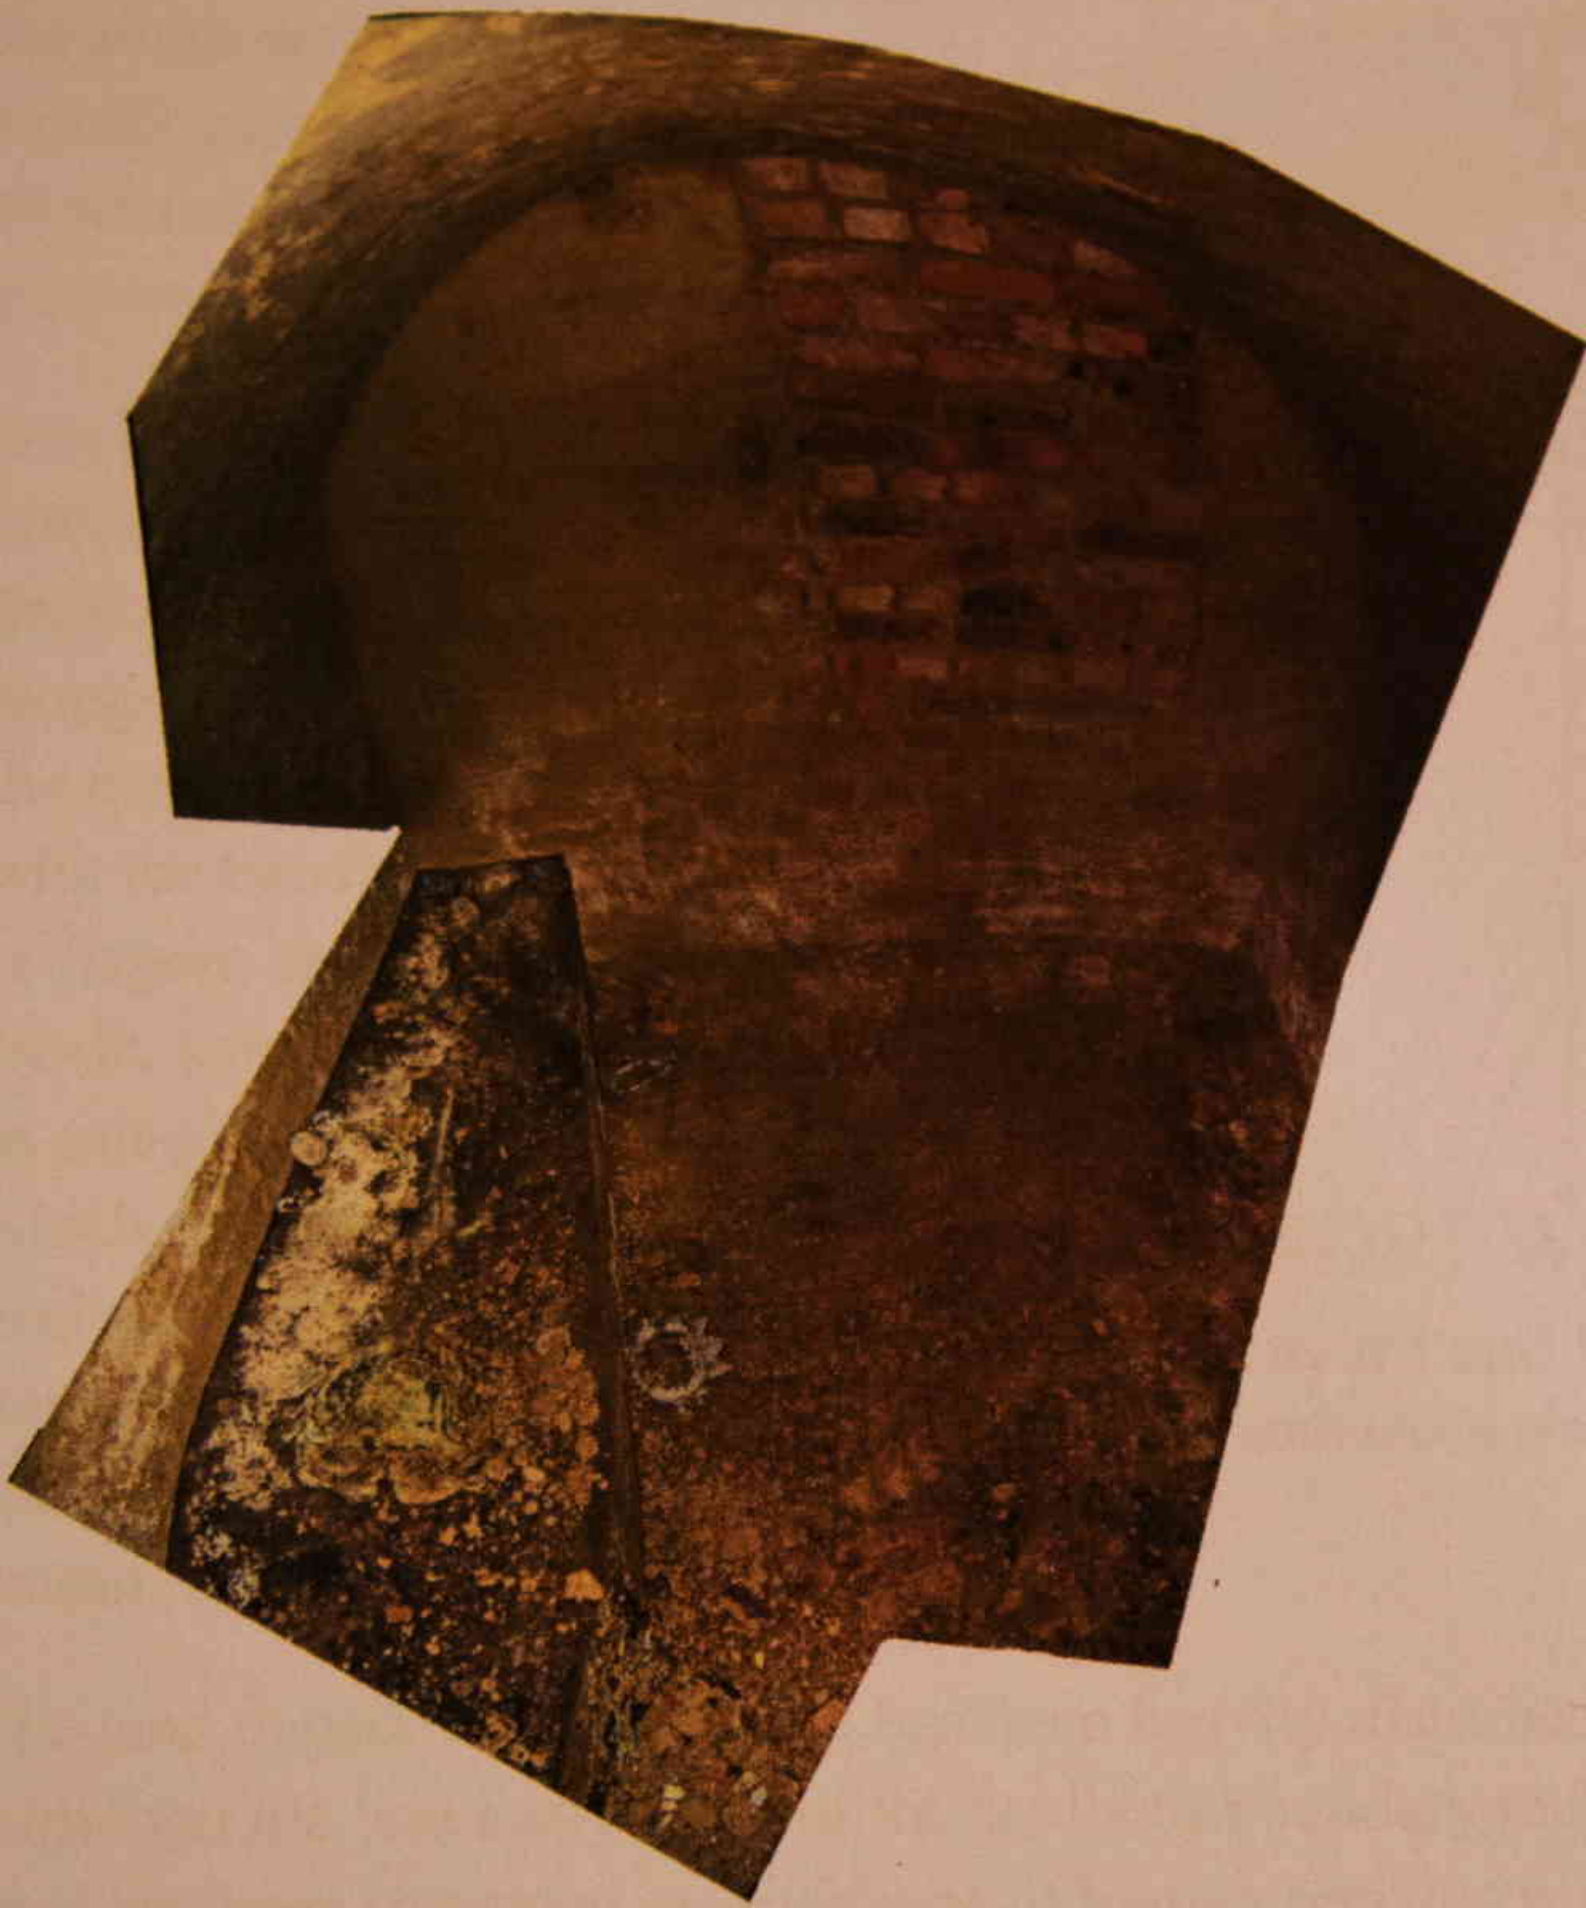
Entry into the vault was at the north end of the east wall, where there was a panel of exposed brickwork (otherwise the walls and vault were plastered over). The 'VAULT ENTRANCE' slab was in the paving above this point.

Composite photograph of the interior of the vault, looking east, showing bricked-up entry

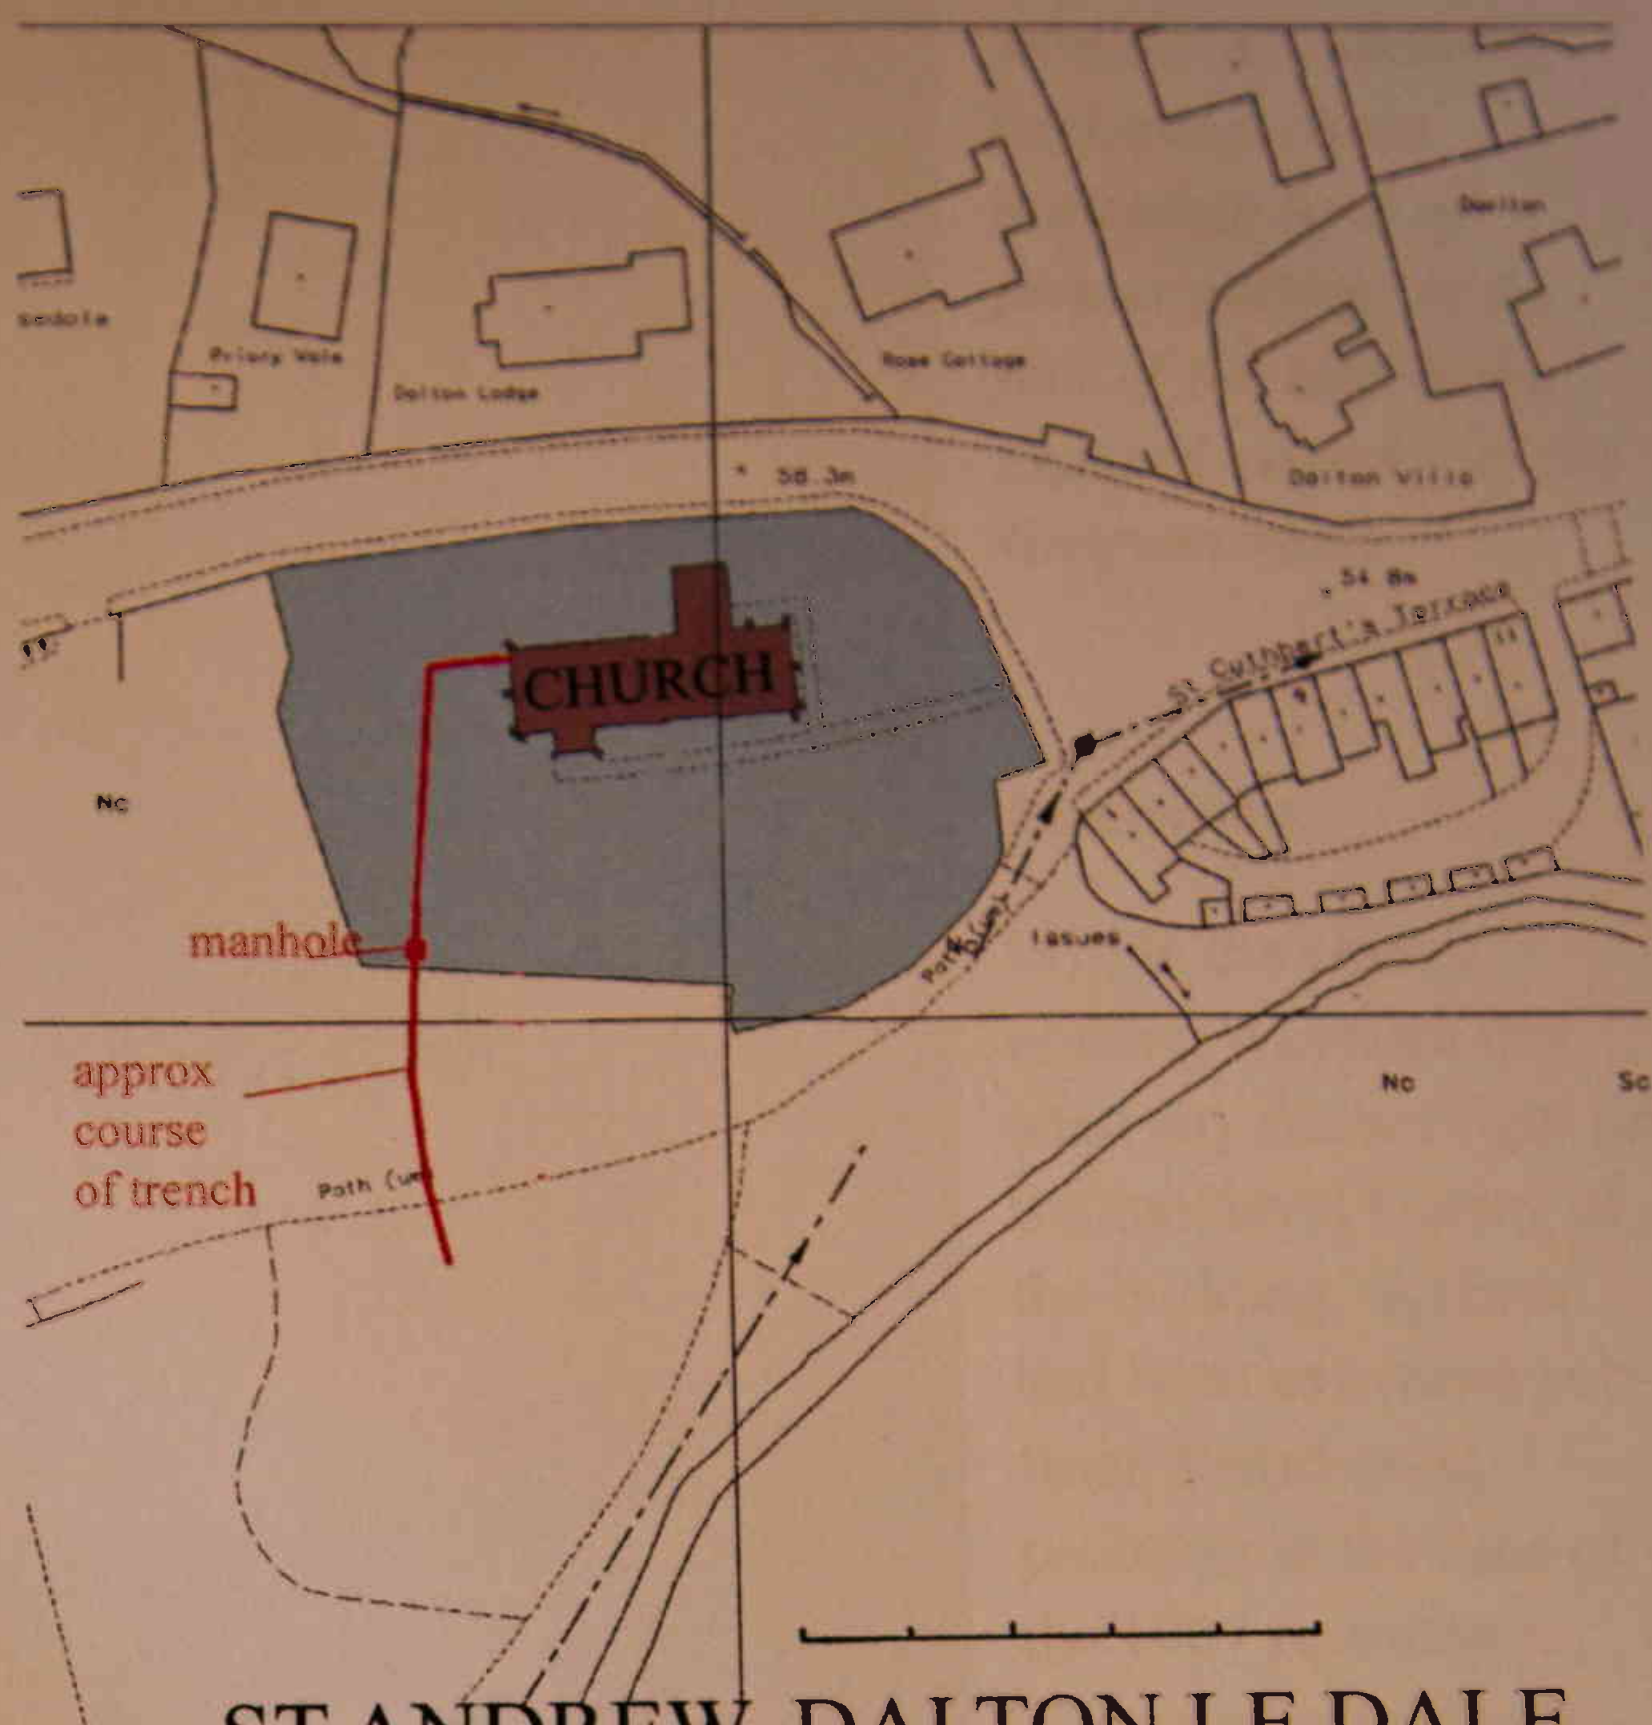
Churchyard and Drainage Trench
(after architect's plan, annotated PFR)

The land outside the churchyard has been heavily disturbed (see Discussion section). Although the 'cut away' plan of the southern boundary makes it seem highly unlikely that the yard has been truncated, no evidence of human remains was seen, but c 1.5 m outside the present boundary (an iron fence) there was a deposit of sea shells (limpets and razor shells) at a depth of c 0.60m, looking to rest on undisturbed subsoil. South of this the ground was disturbed to the full depth of the trench, with modern brick, coal, rubble and debris.

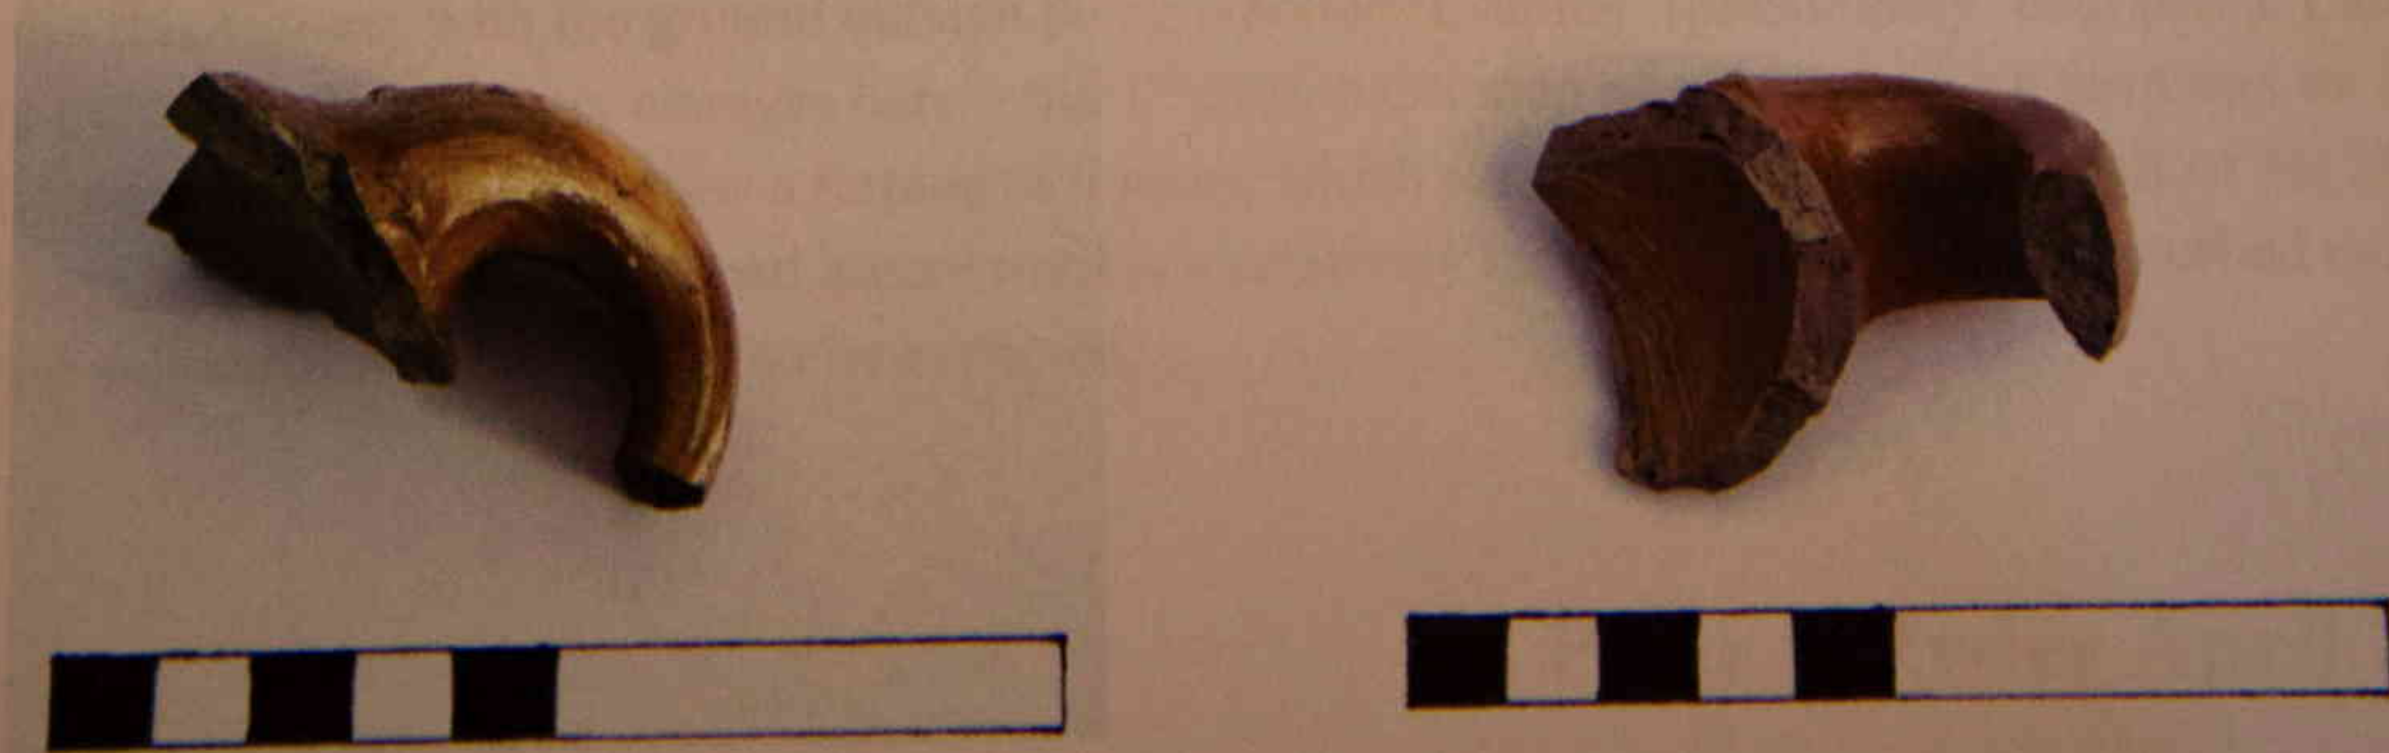
One piece of interesting pottery was retrieved from the contractor's spoil heap alongside the excavation for the manhole. This is a sherd with the handle of a tankard or flagon, in pink/brown fabric, tentatively identified as salt-glazed stoneware, which (if English) is probably of early 18th century date, but could be a century earlier if an import (pers. comm. Richard Carlton).

Flagon handle in salt-glazed stoneware, perhaps early 18th century

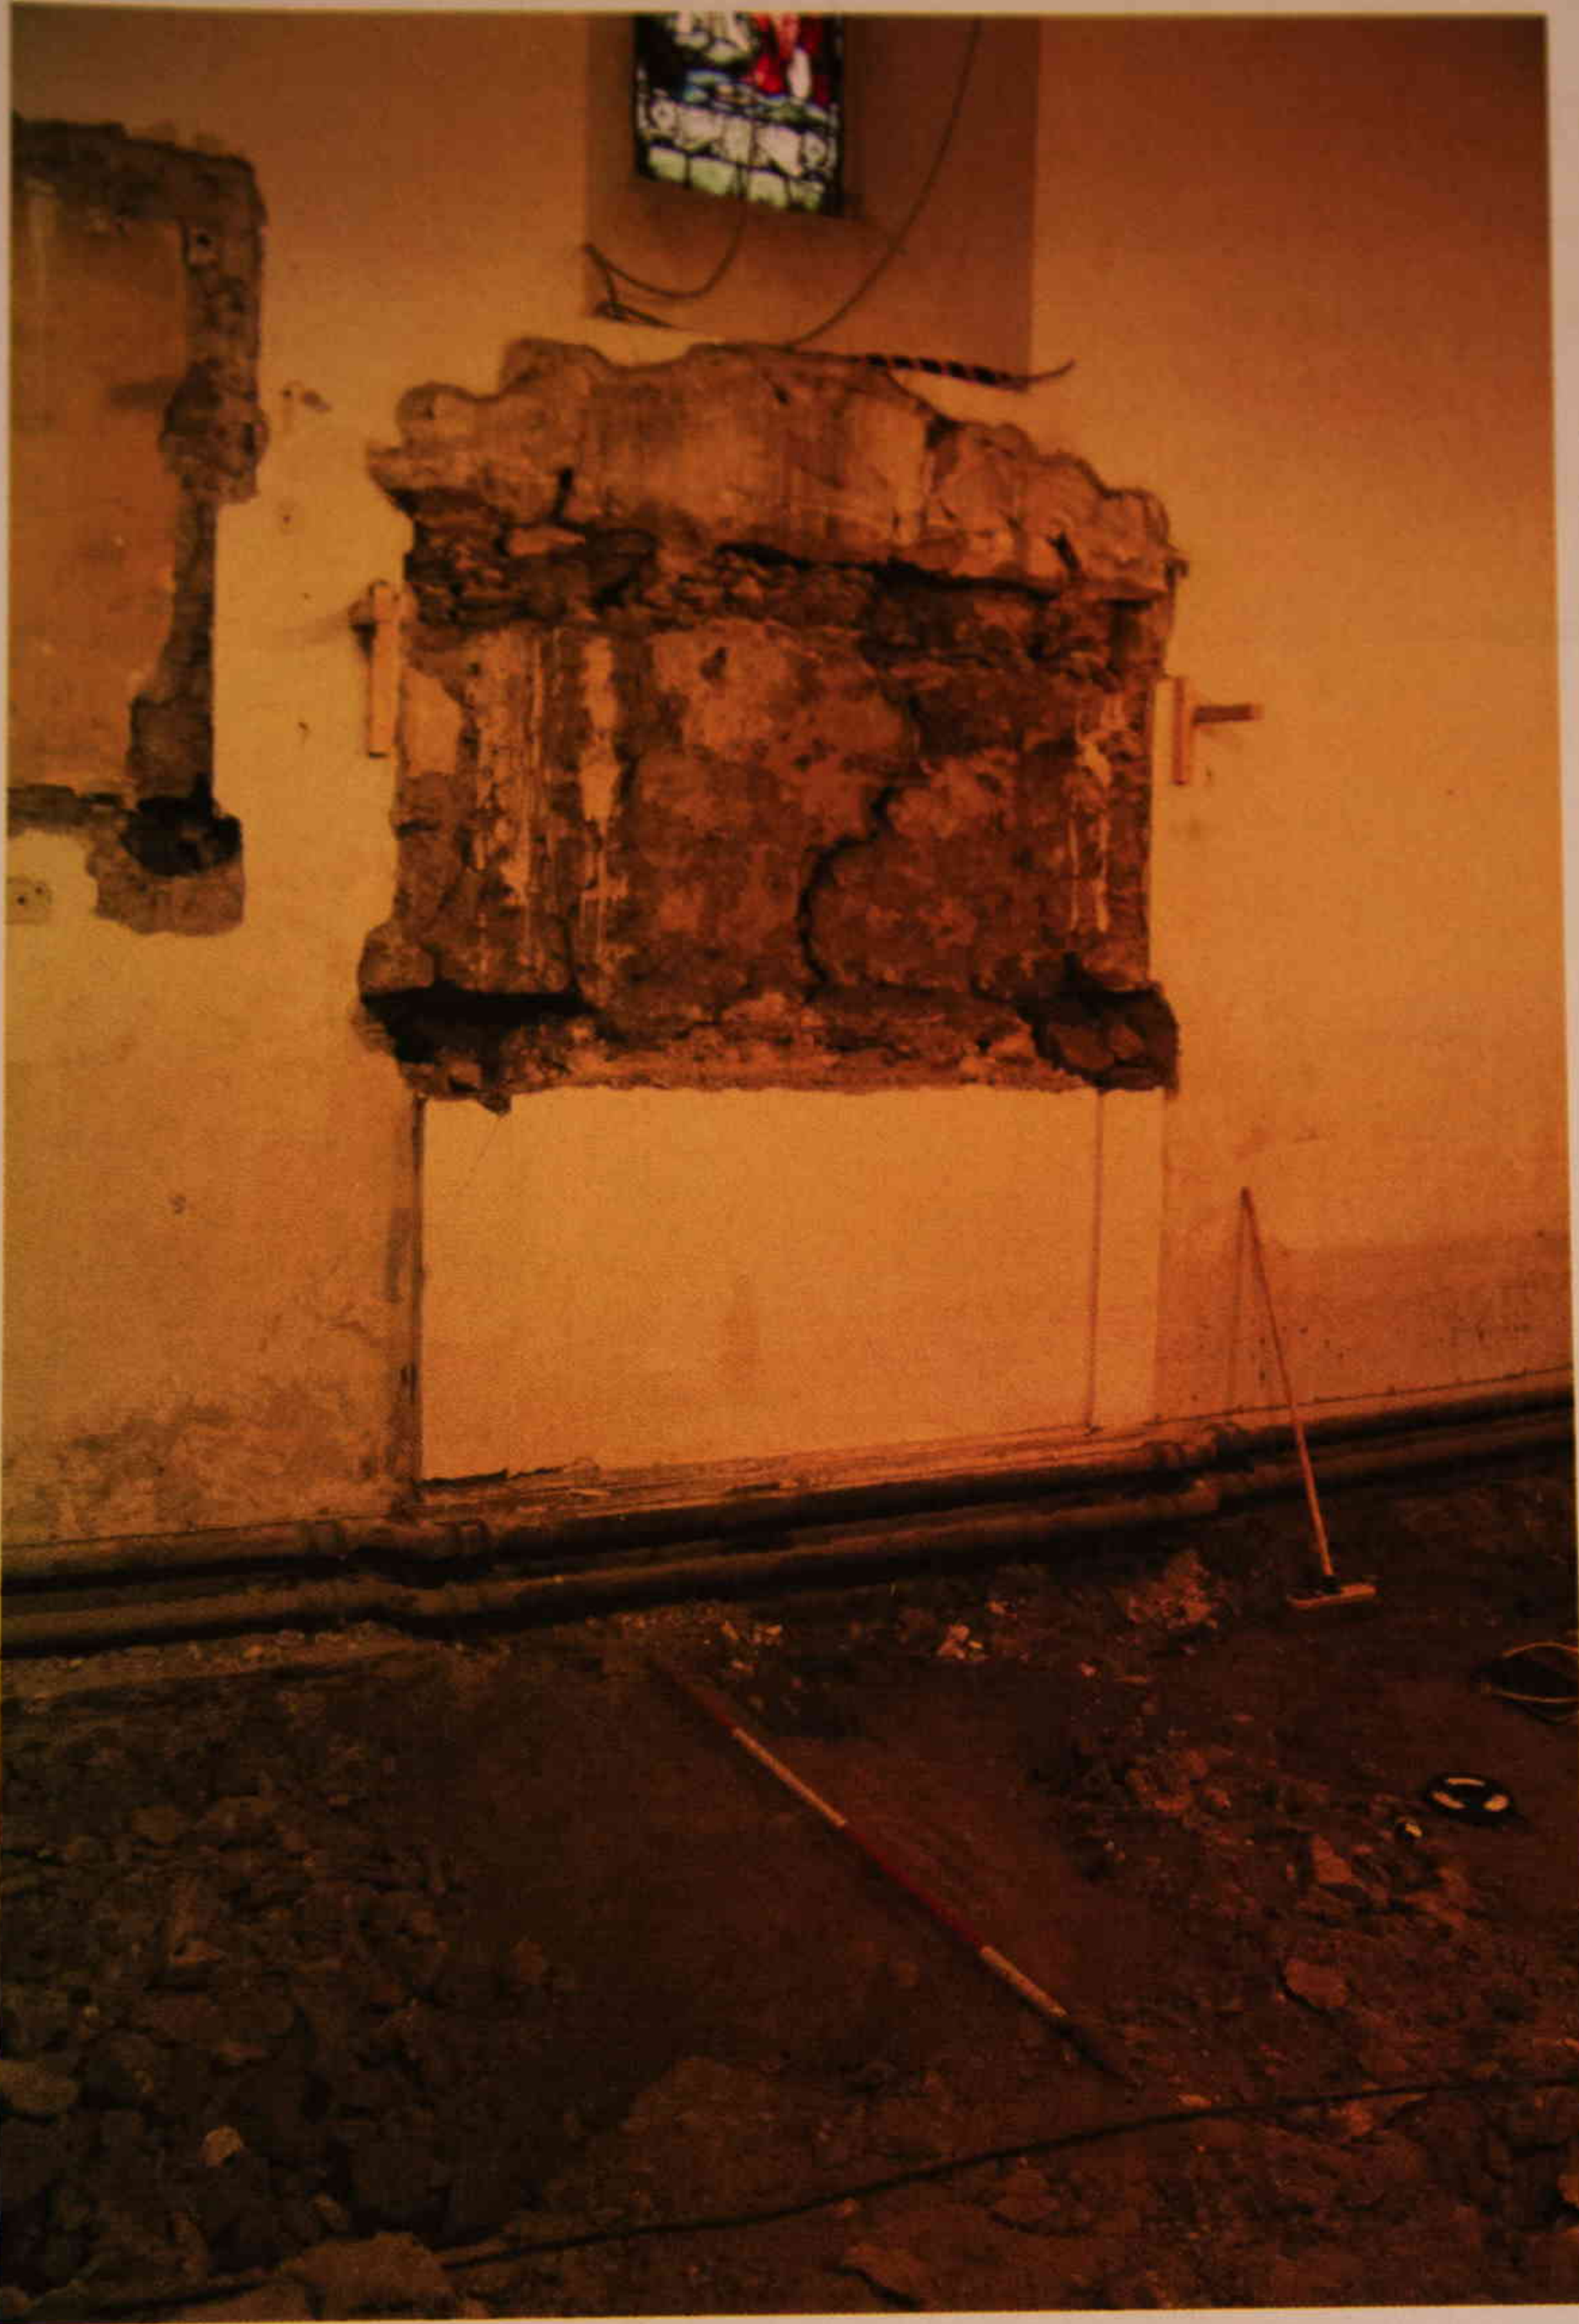
The removal of the wall monuments exposed older wall plaster behind them, and in the case of (1), a crudely-infilled horizontal slot cut into the wall m 2.55 m above the present floor and 0.25 m deep, which would appear to have carried the timbers of a previous gallery¹.

The west wall after the removal of the monuments, showing horizontal chase indicating level of former gallery; at the foot of the wall is the exposed extrados of the Gregson vault.
