St Andrew, Dalton le Dale
An Archaeological Watching Brief

February/March 2011

St Andrew's Church, Dalton le Dale.

An Archaeological Watching Brief, February/March 2011

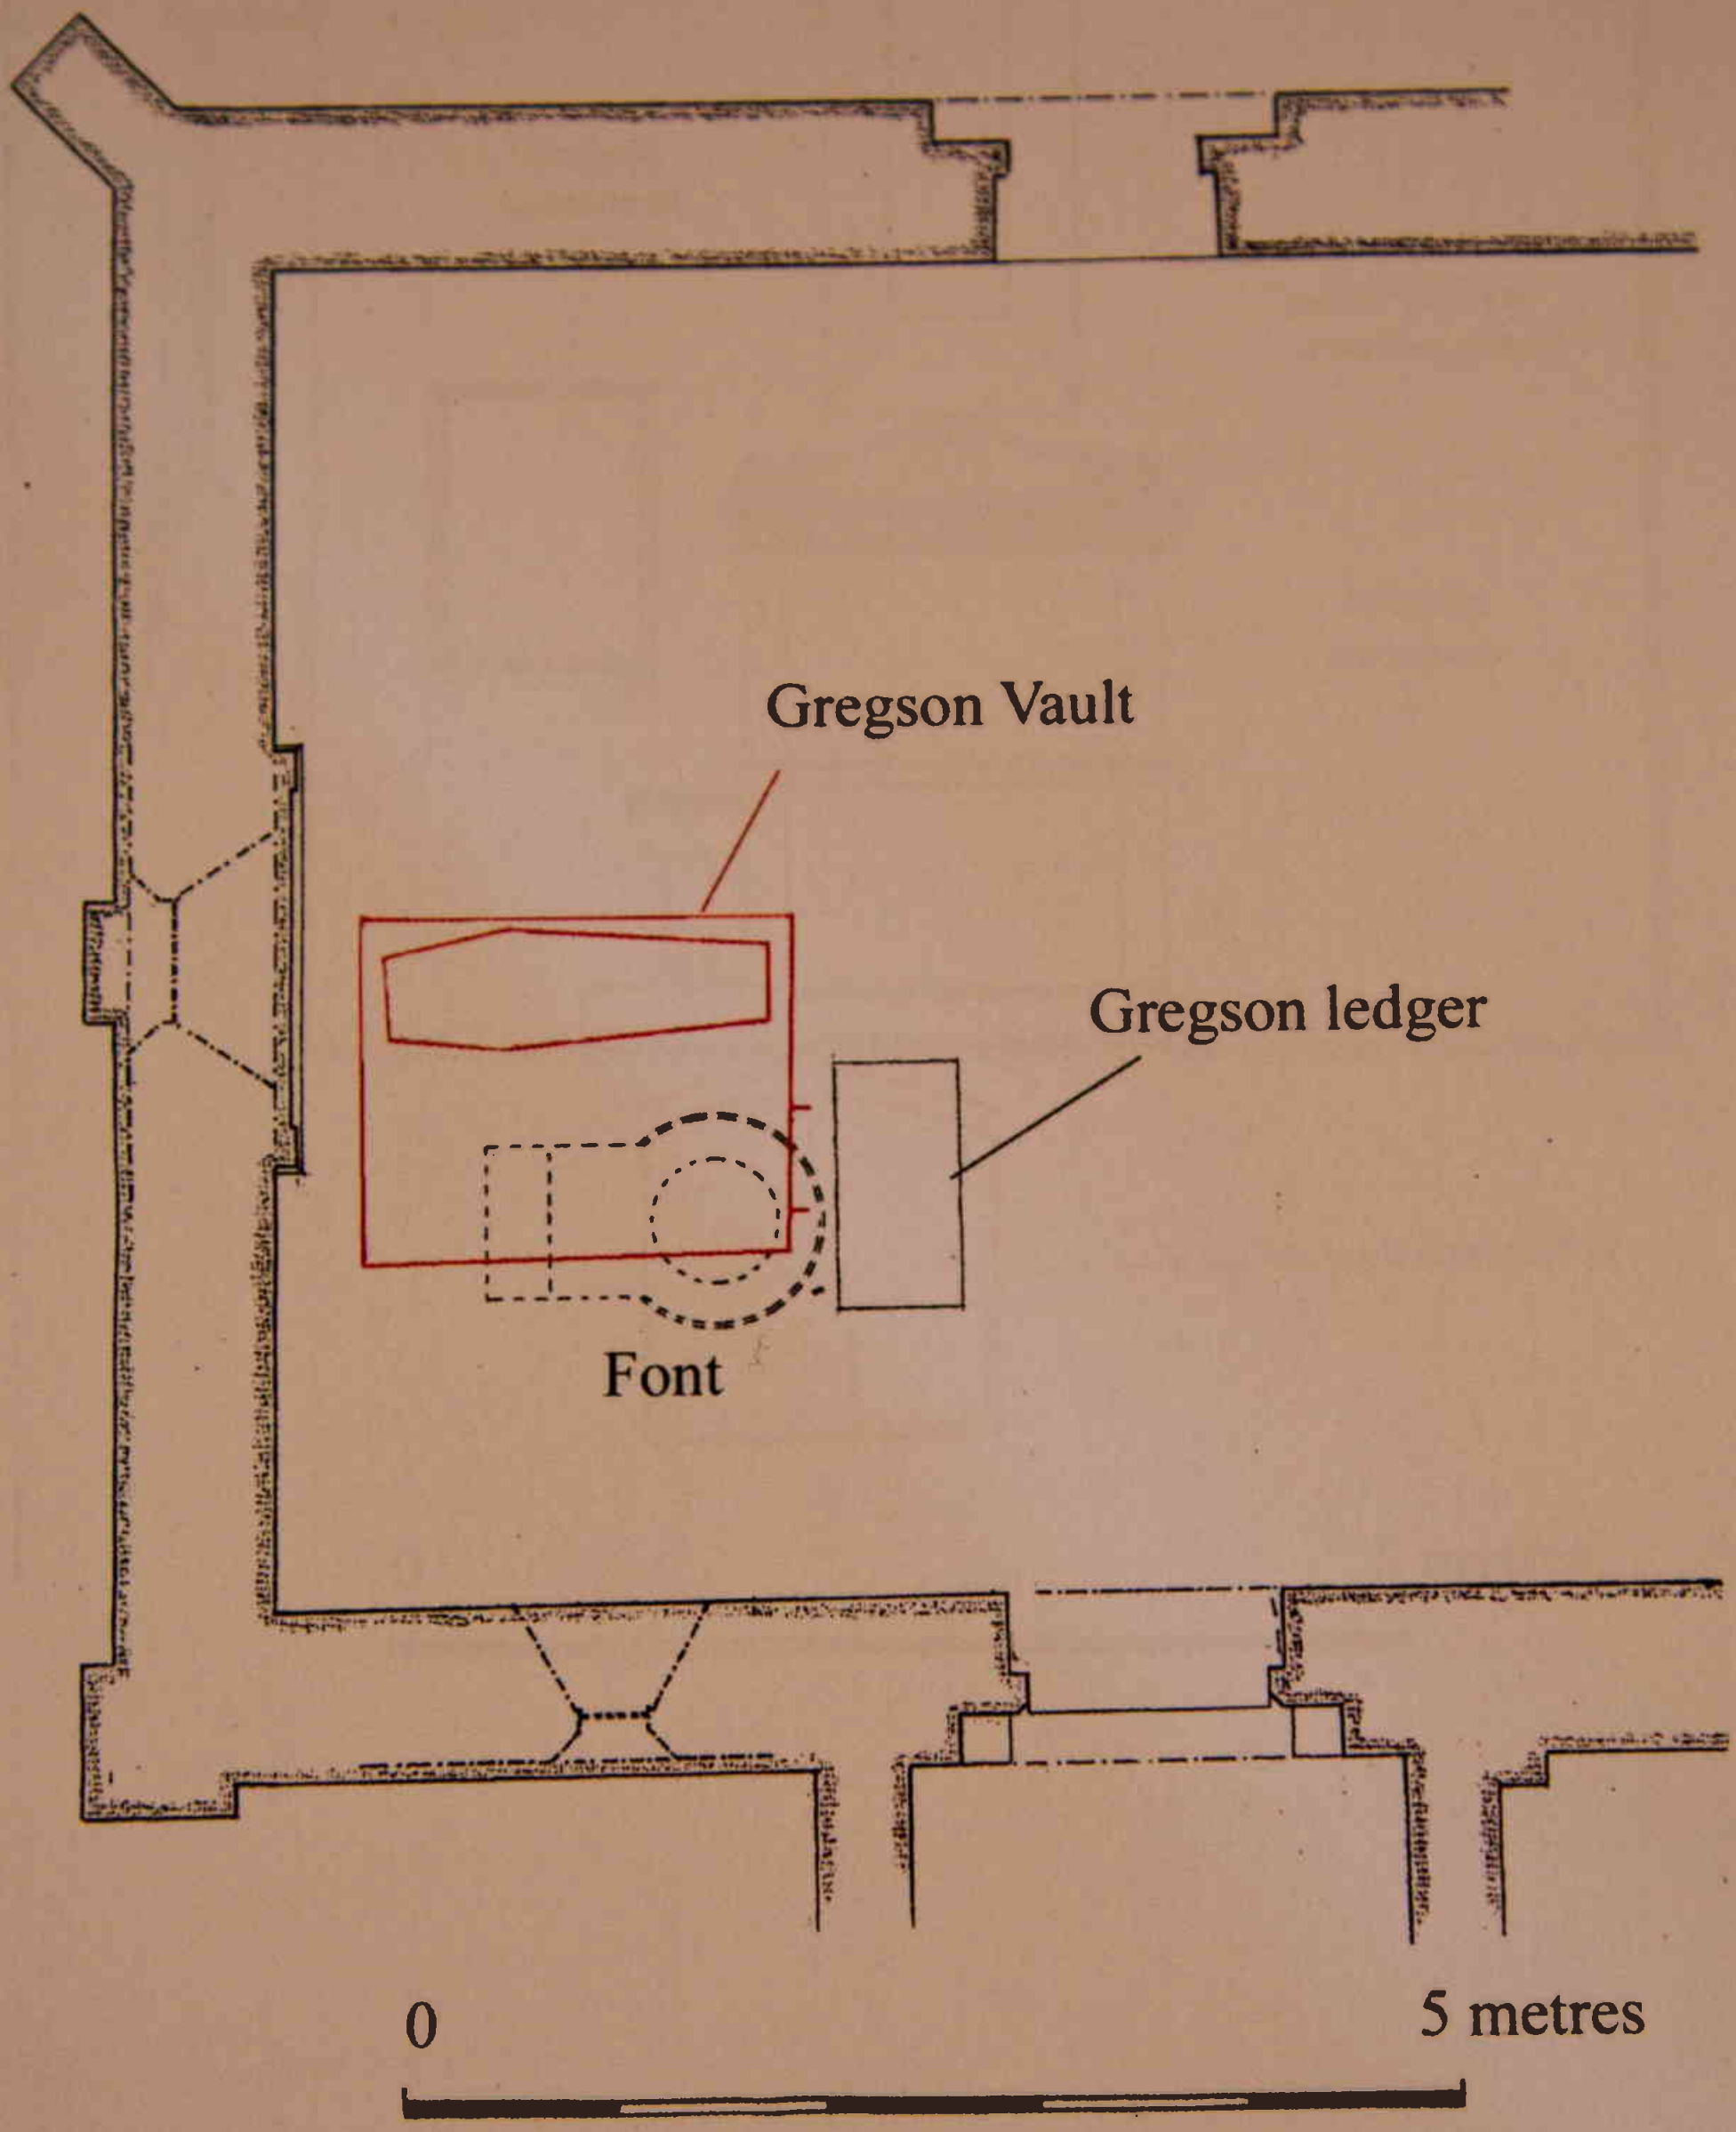
N **ST ANDREW, DALTON LE DALE**
West End of Nave, after survey by C Downs
annotated PFR April 2011

The relatively-recent paving of the floor was removed, exposing a layer of rubble with brick fragments, all of 20th century date; excavations to a depth of 50 cm were made for the piers supporting the new gallery, but these too appeared to be in disturbed ground. Beneath the font was a soakaway, roughly lined with brick, which the contractors stated 'went down about four feet'; this too was clearly fairly recent, as the font had only been moved into that position in the mid-20th century. The only feature of archaeological interest exposed was the top of a brick-arched vault set against the west wall, a little south-of-centre, which clearly related to the adjacent monument.

This was a brick-walled structure, set east-west, internally measuring 2.07 by 1.77 m, and 1.77 m high to the crown of the segmental vault, which consisted of a single skin of brick 110mm thick; the extrados of the vault lay c 100 mm below the floor paving. The removal of a few bricks against the west wall allowed the interior to be photographed and roughly measured. In the vault a single coffin lay against the north wall. The coffin, of traditional six-sided form, is probably of lead, although only the decaying wooden outer was visible. It bore a central shield-shaped plate with the inscription, in gold lettering on a black field:

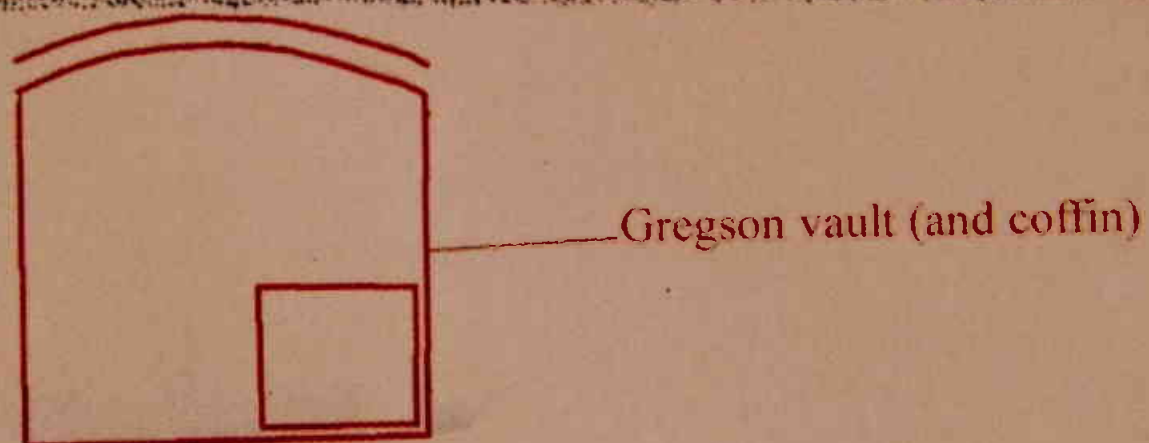
Internal Elevation of West Wall of nave (after survey by C Downs)

The removal of the wall monuments exposed older wall plaster behind them, and in the case of (1), a crudely-infilled horizontal slot cut into the wall m 2.55 m above the present floor and 0.25 m deep, which would appear to have carried the timbers of a previous gallery¹.

Both of the wall monuments were removed to accommodate the new gallery, no (1) being re-set at a lower level (without its plain lower panel), beneath the gallery, and no (2) above it. The inscribed slabs in the floor were both re-set in new positions alongside the west wall.
